# RESEARCH MEMORANDUM

FLIGHT EXPERIENCE WITH TWO HIGH-SPEED AIRPLANES  
HAVING VIOLENT LATERAL-LONGITUDINAL  
COUPLING IN AILERON ROLLS

By NACA High-Speed Flight Station

NACA RM H55A13

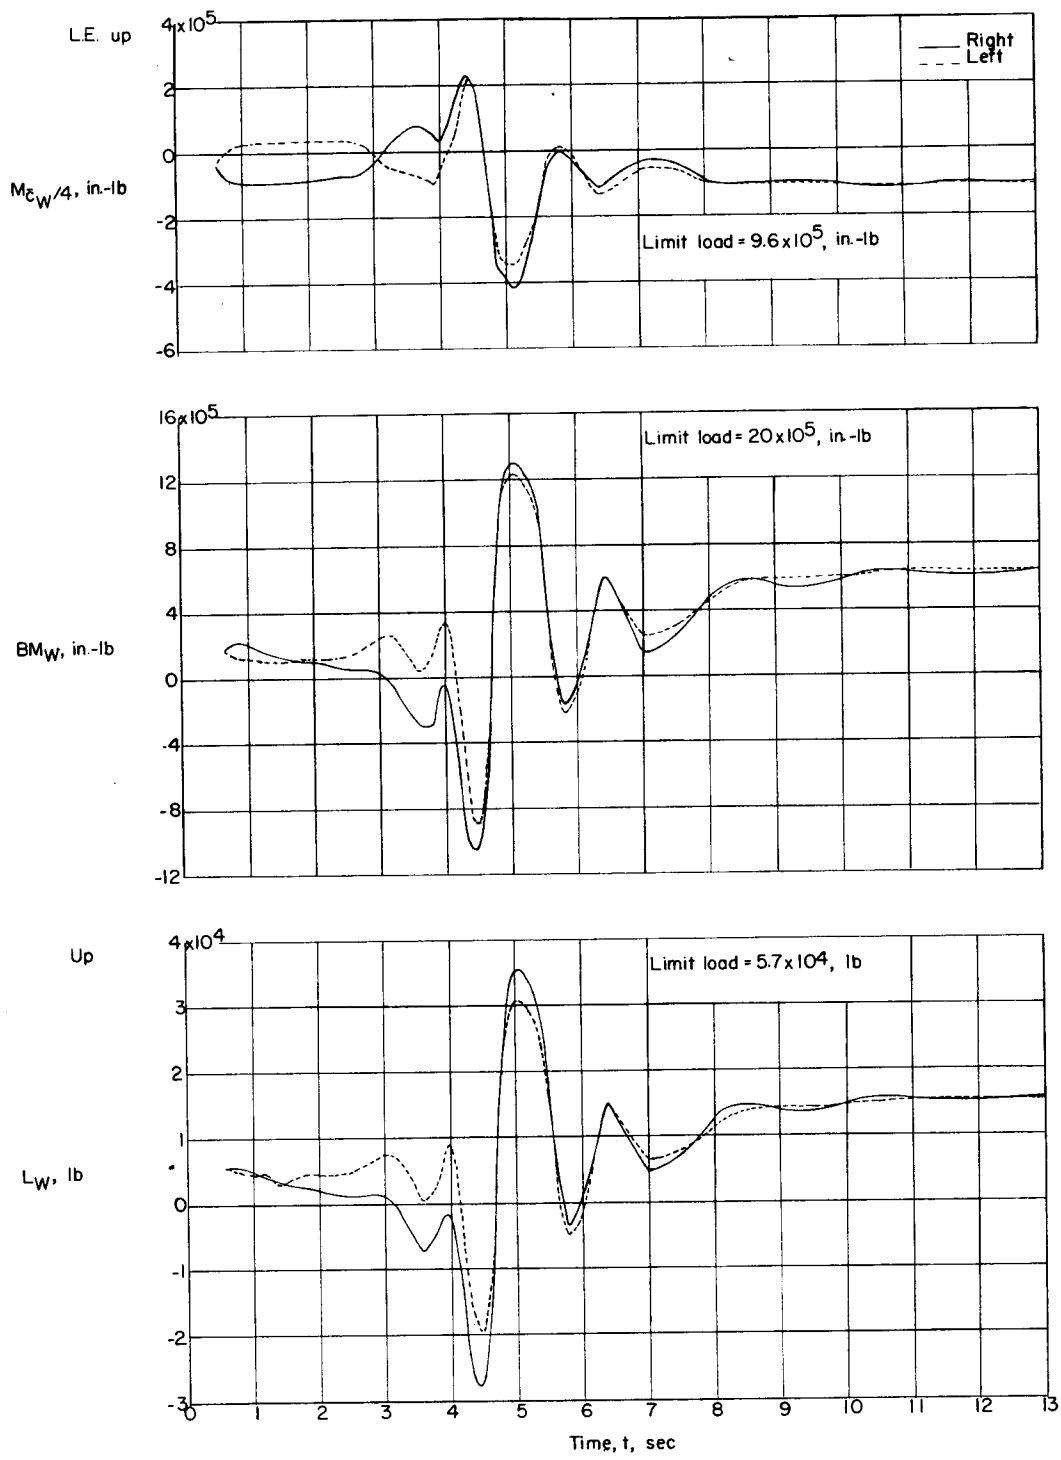
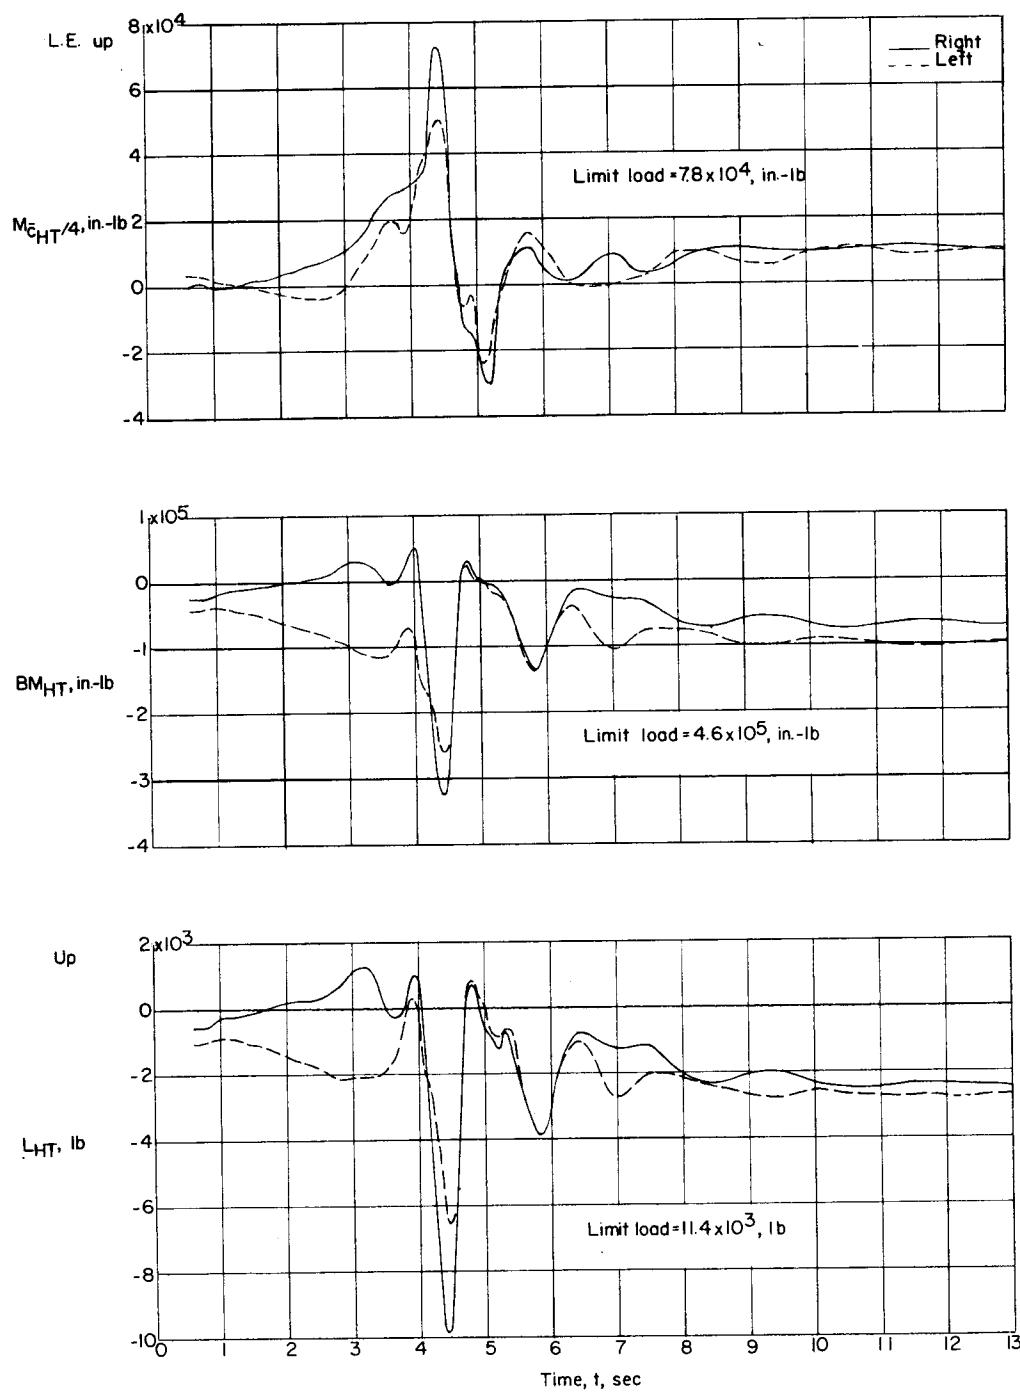
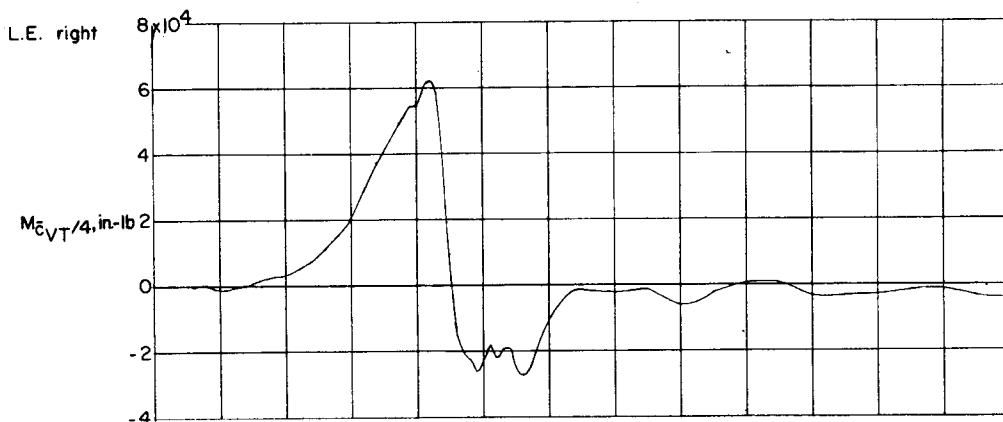
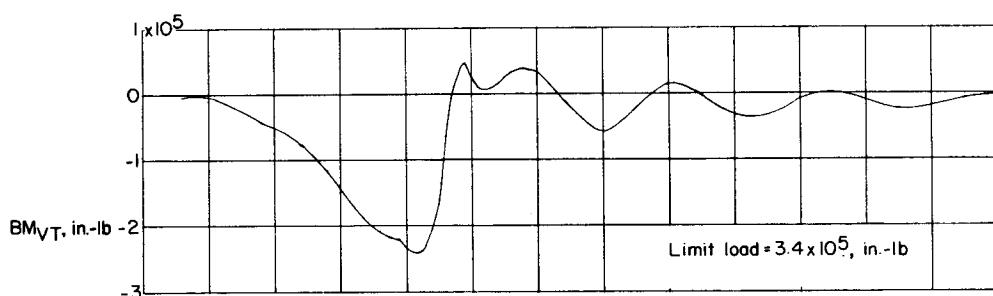
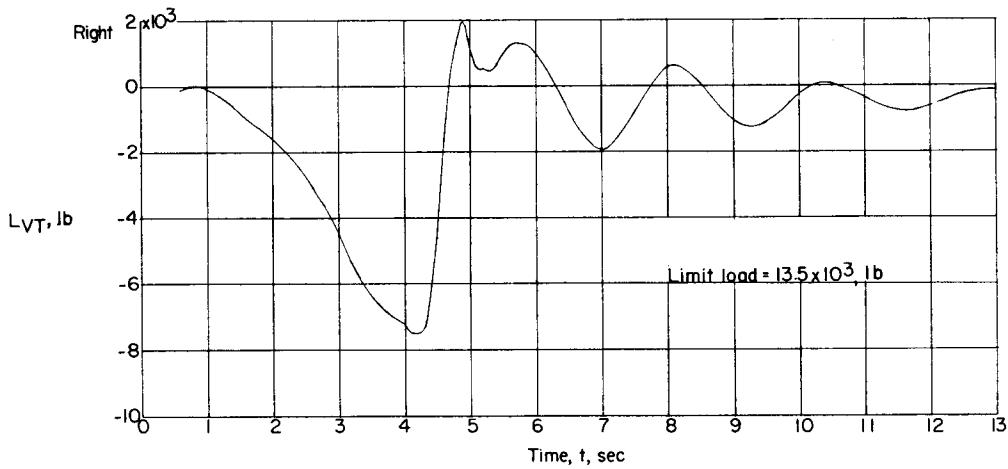
(c) Wing structural loads.

(d) Horizontal tail structural loads.

(e) Vertical tail structural loads.

Another left roll time history for airplane A is presented in figure 6 for a Mach number of about 1.05. During this maneuver the favorable sideslip builds up rapidly with roll velocity and peaks at 21° at the time the airplane ceases rolling left. This large sideslip angle results in about 2g transverse acceleration. Near the time at which maximum sideslip occurs ( $t \approx 4.0$  sec) a large divergence in pitch develops in the negative direction which attains about -6.7g. The pilot applied control to stop this pitch-down and immediately reduced the control deflection, but was unable to avoid obtaining 7g when the airplane pitched up. Maximum wing loads measured during the maneuver did not approach or exceed the design limit load (fig. 6(c)); however, the fuselage load obtained from airplane weight and acceleration, and horizontal tail loads, and wing load showed maximum values of 63,000 pounds. These maximum values approximated the limit design total load of the fuselage. The measured horizontal tail loads were near limit design load (fig. 6(d)). The maximum measured vertical tail loads reached approximately 50 percent of the limit load (fig. 6(e)) at sideslip angles of 21°. It may be noted that a reduction in vertical tail load with sideslip was experienced at sideslip angles about 8°. In this maneuver, as in figure 5, when the rolling stopped, the airplane motions quickly damped.

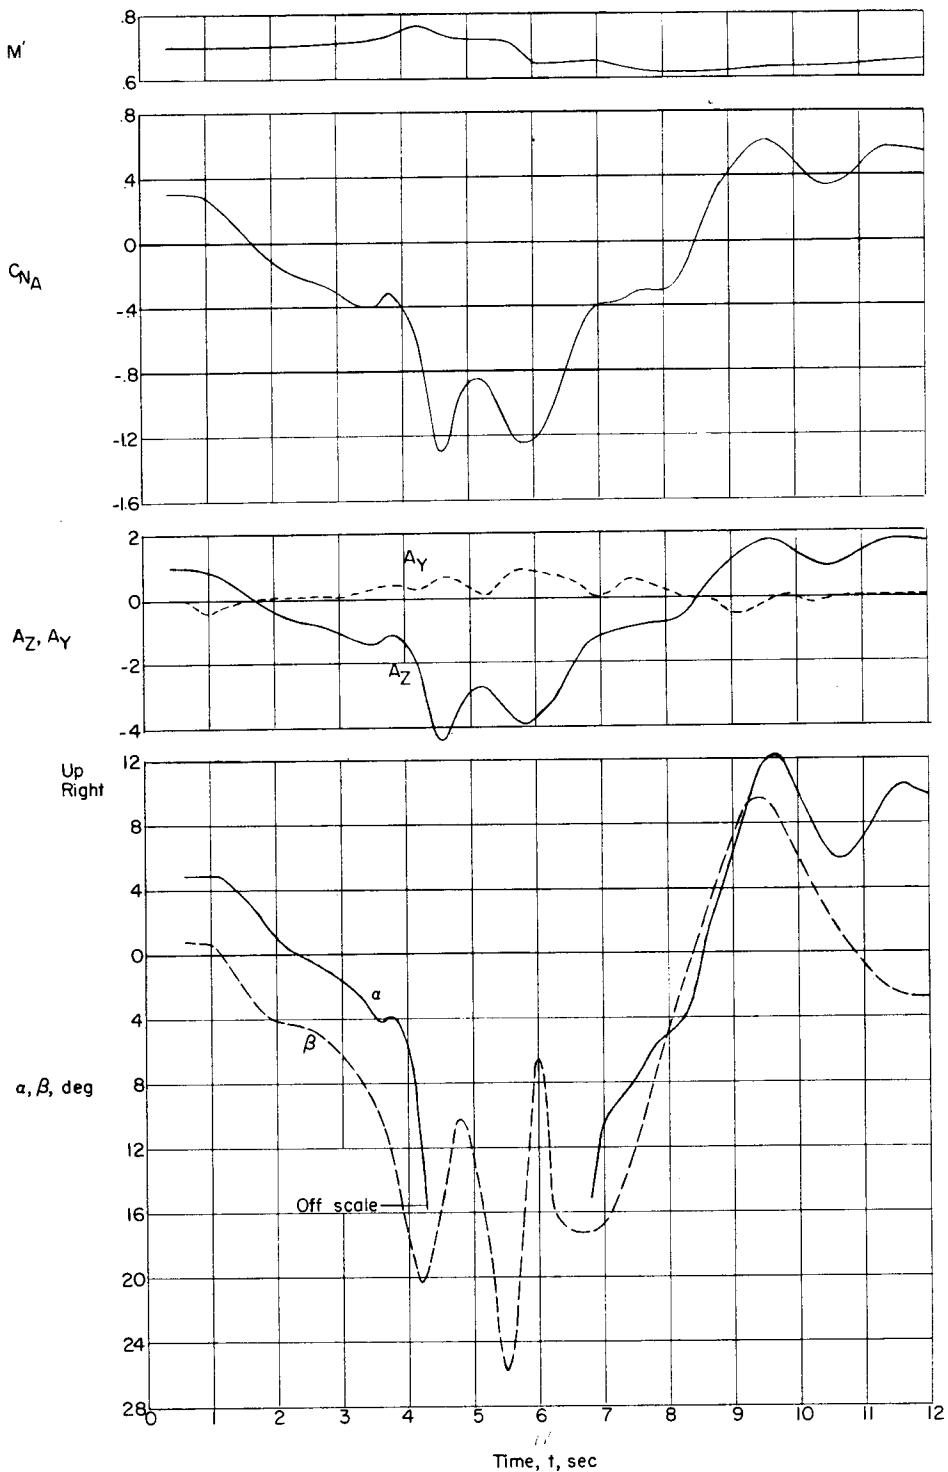
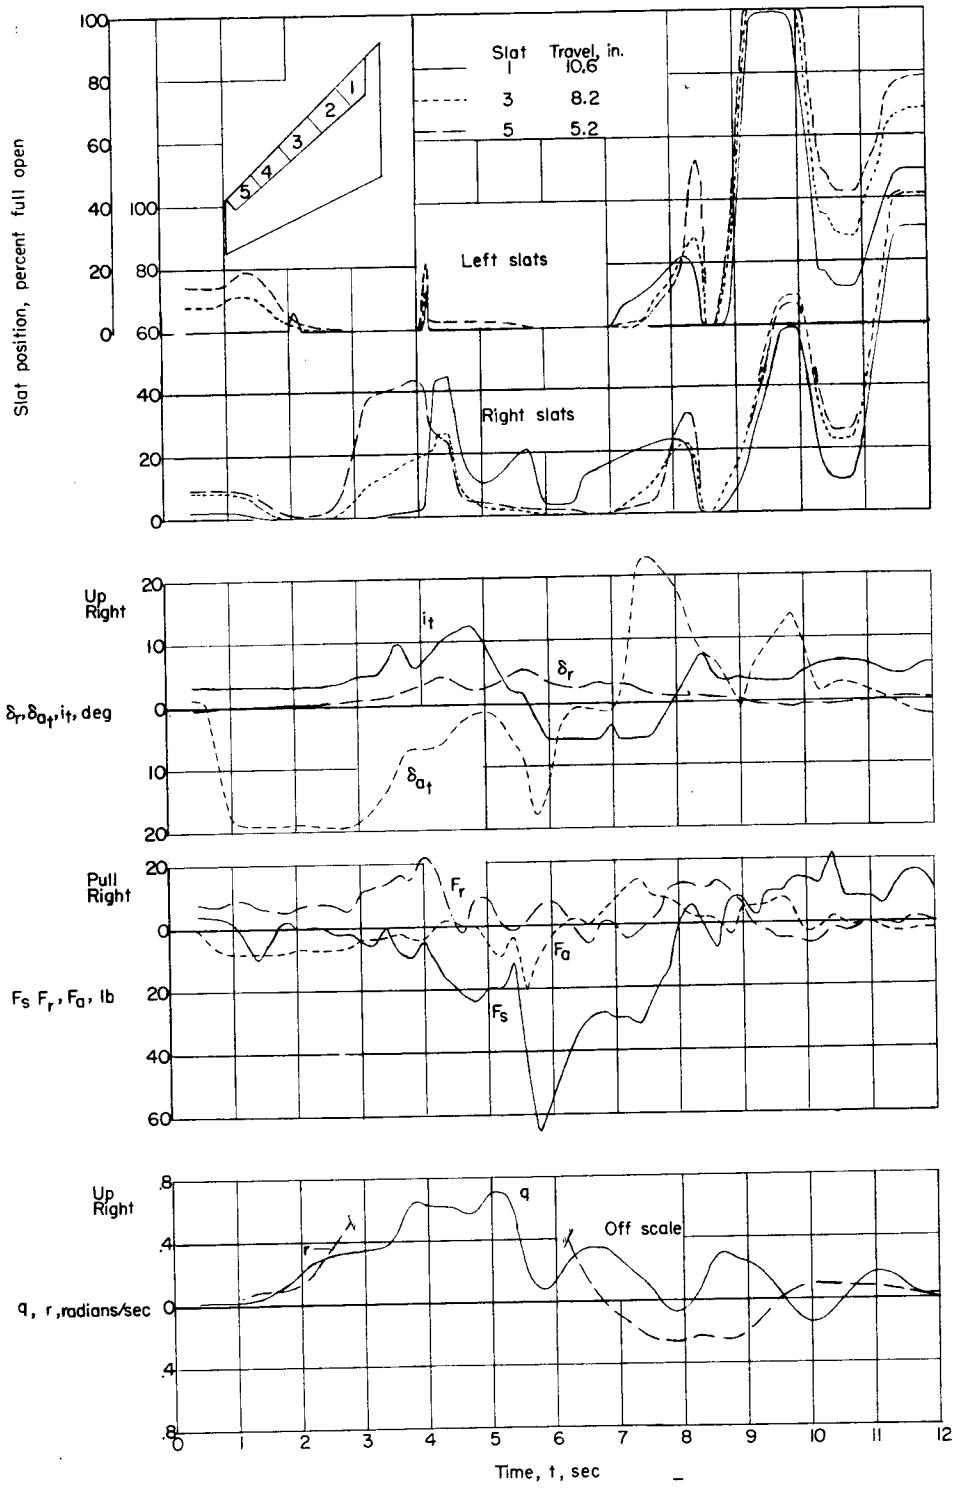
(a) Stability and control plots.

Figure 7.- Time history of quantities measured during abrupt aileron roll with airplane B at  $M = 0.70$ .  $h_p \approx 30,000$  feet.

(b) Stability and control plots.

The measured quantities for an abrupt left aileron roll for airplane B at an altitude of 30,000 feet and a Mach number of 0.70 are shown as

figure 7. Unfortunately, the roll record was lost as a result of instrument malfunctioning. As peak aileron deflection is attained, there is a steady development of left (adverse) sideslip and a progressive decrease in angle of attack. Between  $t = 3$  seconds and  $t = 4$  seconds, the divergence rates are accelerated considerably and negative angles of attack greater than  $16^\circ$  ( $-4.4g$ ) and left sideslip angles as large as  $26^\circ$  were reached in the more violent stages of this maneuver. Maximum vertical tail loads of 5,500 pounds were measured at a sideslip angle of  $26^\circ$  (fig. 7(c)). It may be noted that appreciable reduction in the rate of increase of vertical tail loads with increase in sideslip angle occurred at a sideslip angle of  $7^\circ$ . It also should be noted that a rather large stabilizer input to oppose the motion and a small rudder input to aggravate the motion were fed in by the pilot. Recovery was affected by bringing the stabilizer and rudder controls close to their initial settings and permitting the airplane to recover. The slat motions shown result from aerodynamic and inertia loads, the slats being free floating but with the segments loosely interconnected.

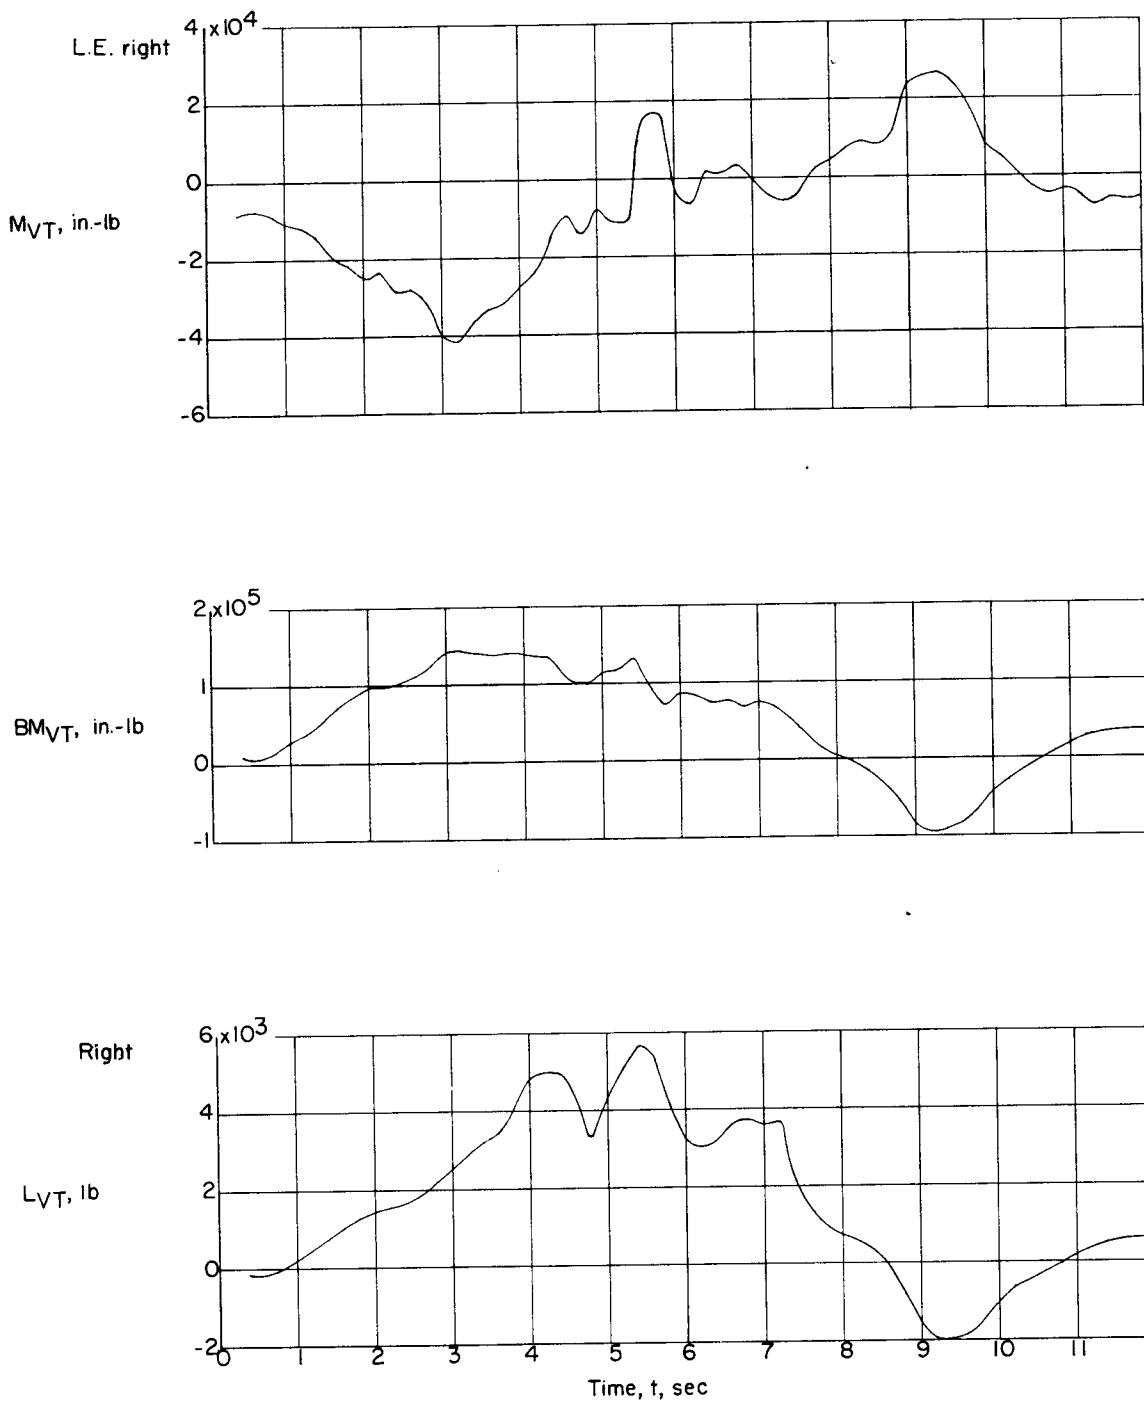
(c) Vertical tail structural loads.

Figure 7.- Concluded.
